Measuring the Impact of Interior Insulation on Solid Masonry Walls in a Cold Climate

Conference Paper - 0910

J. Wilkinson¹, D. De Rose¹, J.F. Straube², B. Sullivan¹

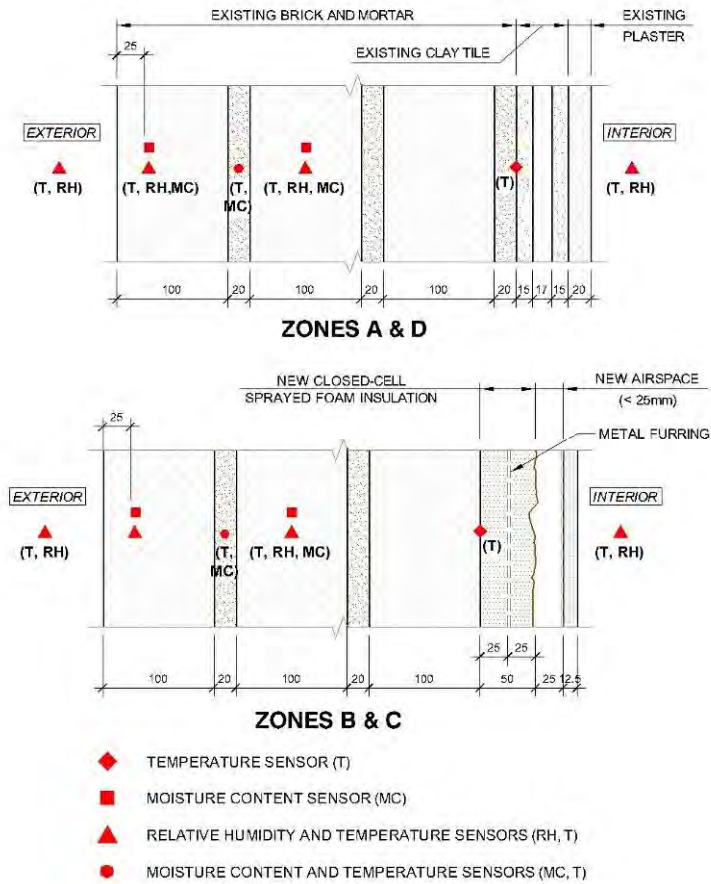
FIGURE 1: MOCK-UP WALL SECTIONS

Zones A&D: existing un-insulated wall assembly, zones B&C: modified insulated wall.

Nine sensors were installed in each wall to measure temperature, relative humidity and moisture content at various locations across the wall (see Figure 1). Exterior temperature and relative humidity were measured directly outside the test walls. Driving rain was measured on the exterior of the walls, at the bottom of Zones B and C (South and East). Interior temperature and relative humidity were also measured at two locations within the test room.

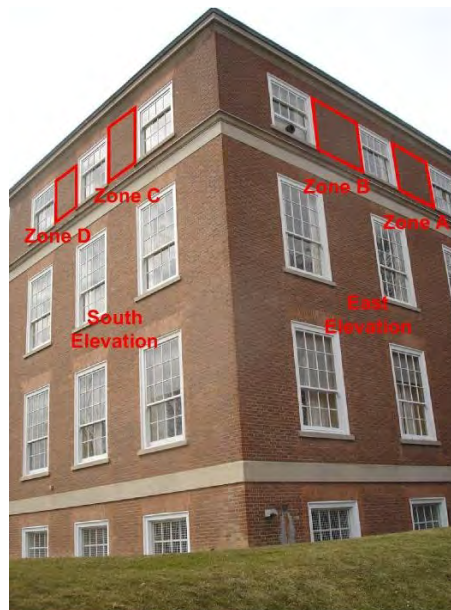
PHOTO 1: EXTERIOR SOUTH-EAST CORNER

All wall mock-up zones shown, zones A/B (East elevation), zones C/D (South Elevation).

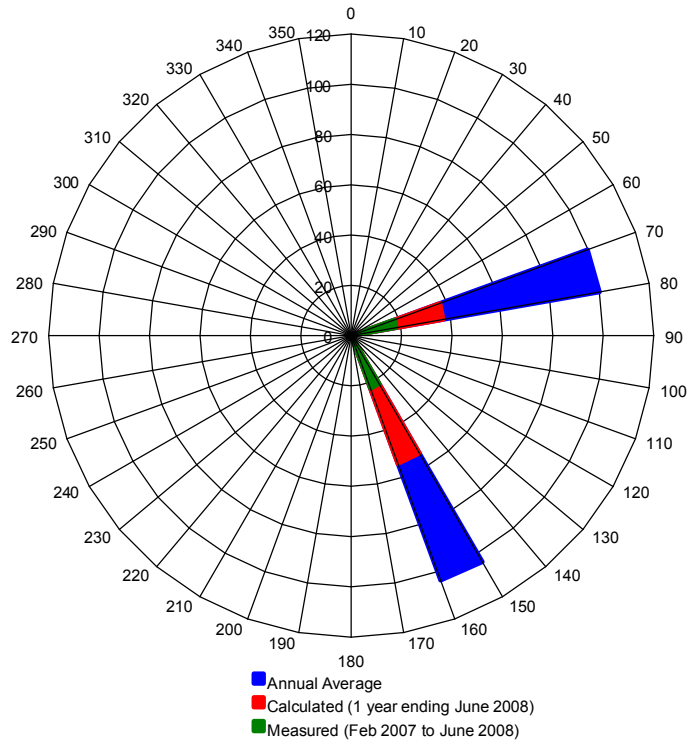
FIGURE 2: WIND-DRIVEN RAINFALL ON TEST WALLS

Wind driven rain shown is for various periods using Toronto Pearson airport and Queen’s Park weather stations. A rain deposition factor of 0.5 is used, as determined by on site wind-driven rain measurement.

Below-Average Wall Wetting: Expected driving rain at the site was calculated using publicly available vertical rainfall, wind direction and wind speed data from nearby Queens Park (calculated per procedures described in Straube and Burnett (2005)). A rain deposition factor of 0.5 was used, as determined by comparing calculated wind driven rain from the data noted above against measured wind driven rain on site. Based on this evaluation, the monitored walls were only exposed to about half the driving rain that occurs in an average year, as shown in Figure 2. While there was less-than-average driving rain on the South and East elevations over the period under review, there was significant vertical rainfall over this period. Unfortunately, most of this rain was driven onto the N, W and SW elevations. In fact, these elevations experienced 2.5 times the average rainfall. In short, this was an uncharacteristic year for driving rain, with less driving rain from typical directions and more from atypical directions. As the conditions on the monitored walls provide below-average conditions for evaluating freeze-thaw or corrosion risks, the monitoring results were used in combination with computer modelling to further evaluate deterioration risks.

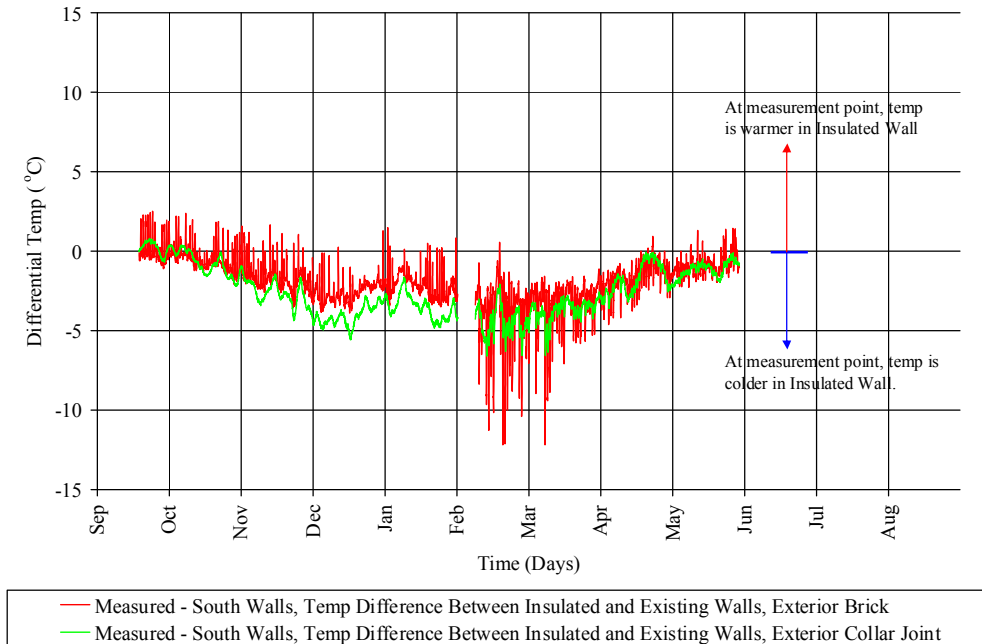
FIGURE 3: MEASURED TEMPERATURE DIFFERENCE BETWEEN INSULATED AND EXISTING WALLS
 Temperature difference between East mock-up walls at critical locations for freeze-thaw evaluation (exterior brick and exterior collar joint). Generally the insulated wall is up to 12°C cooler than the existing wall.

The measured insulated walls were cooler than the measured un-insulated walls throughout the winter. At wall locations critical for freeze-thaw damage (exterior brick and exterior collar joint), the insulated walls were up to 12°C cooler than the un-insulated walls (see Figure 3). This resulted in up to 5 times as many zero crossings in the insulated walls. The increase in zero crossings was most pronounced on the South exposure, where cooler walls were subject to increased daily heating from the sun (see Figure 4).

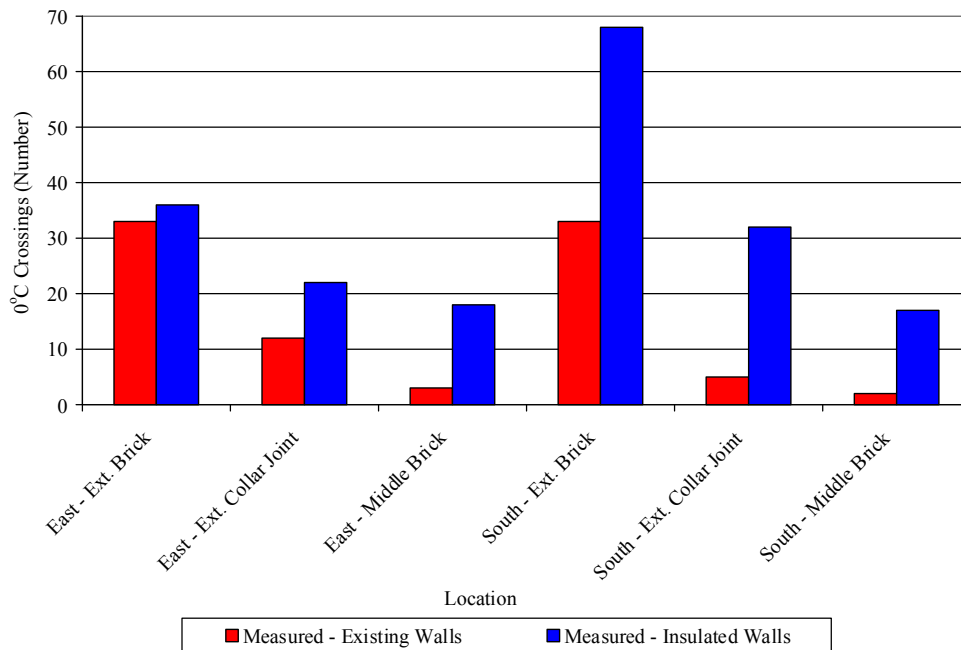
FIGURE 4: MEASURED ZERO-CROSSINGS IN INSULATED AND EXISTING WALLS
 This figure illustrates climate conditions relevant to freeze-thaw cycles. All insulated walls have an increase in the number of zero crossings, particularly the South elevation due to impacts from solar radiation. There were no hours when freeze thaw cycles were observed (when a zero crossing occurred and moisture contents were also above 85% of free water saturation).

Below-Average Number of Zero Degree-Crossings: The monitored walls were exposed to 70% of the zero degree-crossings that would result during the 3rd coldest year in 30 (10th percentile) from the computer model database. The number of zero-crossings is comparable to the amount seen in the 3rd warmest year in 30 (10th percentile) from the computer model database. As these are also below-average conditions for evaluating freeze-thaw risks, the monitoring results were used in combination with computer modelling to further evaluate deterioration risks.

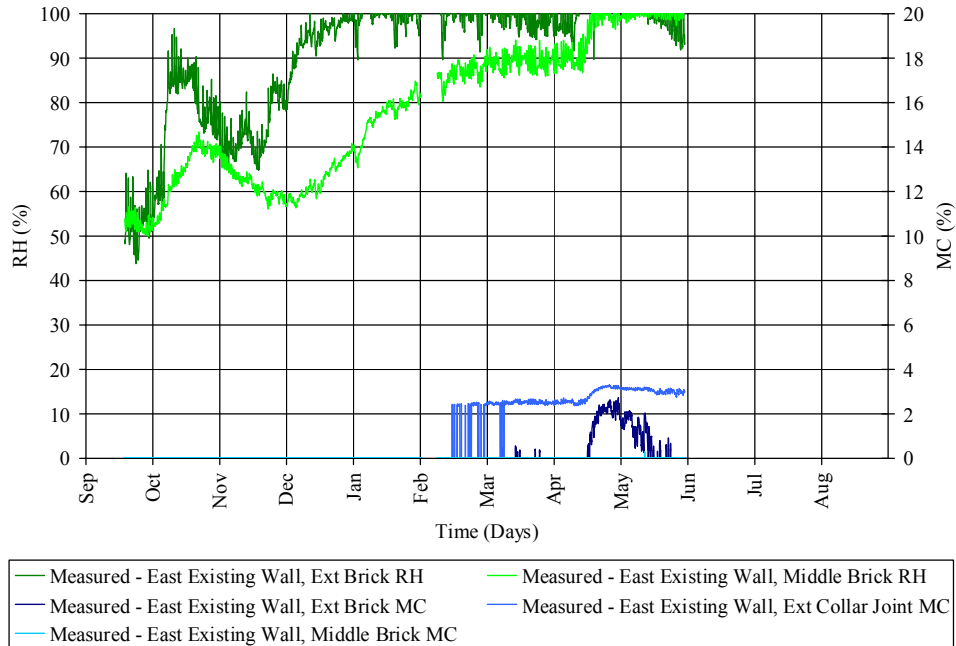
FIGURE 5: MEASURED RH AND MC IN EAST EXISTING WALL

Actual relative humidity and moisture content (wood wafer) measured in the existing East wall. The moisture content is well below thresholds for freeze-thaw. MC values shown are for the wood resistance sensors embedded in the brick, instead of the corresponding brick moisture content in order to increase measurement resolution (see Figures 11 and 12 for wood to brick correlation).

The moisture content in the measured walls was low throughout the monitoring period and, as a result, there were no hours where freeze-thaw damage was likely to occur (see Figures 5 and 6). The maximum monitored moisture content was 4% in the brick and mortar, which is below the estimated 12% threshold where freeze-thaw damage is expected to occur (this 12% threshold corresponds to 85% of the free water saturation). This threshold is expected to be conservative since there should be sufficient room remaining in the pores to alleviate pressures from freezing water.

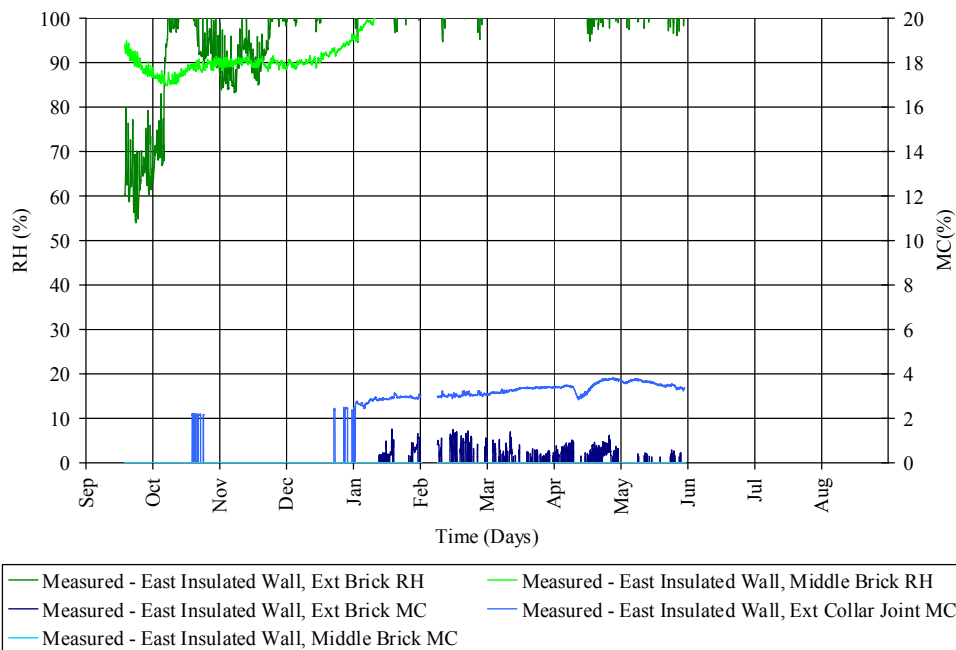
FIGURE 6: MEASURED RH AND MC IN EAST INSULATED WALL

Actual relative humidity and moisture content (wood wafer) measured in the insulated East wall. The moisture content is well below thresholds for freeze-thaw. MC values shown are for the wood resistance sensors embedded in the brick, instead of the corresponding brick moisture content in order to increase measurement resolution (see Figures 11 and 12 for wood to brick correlation).

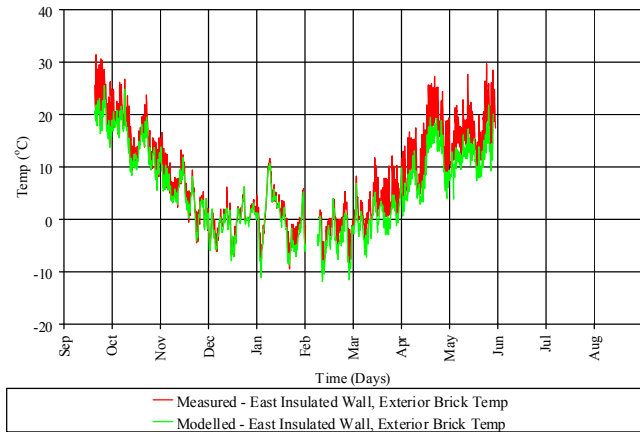
FIGURE 7: MEASURED AND MODELLED TEMPERATURES IN EAST INSULATED WALL
 Temperatures shown are similar between modelled and measured walls. Other locations also compare well.

The hygrothermal performance of the modelled and measured walls generally compared well. The temperatures across the modelled wall sections were within several degrees of one another (see Figure 7), particularly at locations sensitive to freeze-thaw (exterior brick and exterior collar joint). This indicates that the thermal properties of the components are well understood. The relative humidity trends are also consistent between the measured and modelled results, but the modelled values are typically within 10% of the measured values. These results seem reasonable given that a 1-dimensional model is being used to represent 2-dimensional moisture flow through the mortar and bricks. The moisture contents are generally comparable between the calculated/modelled and measured results (see Figure 8). However, there are spikes in the modelled exterior brick moisture content soon after rain events, which do not appear as significantly in the measured walls. This discrepancy is discussed in more detail in Section 4 below. The model was used to evaluate these peak moisture content values, as they are important to freeze-thaw performance.

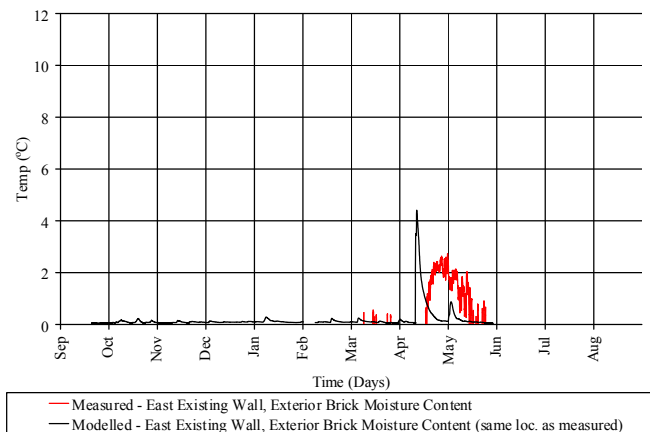
FIGURE 8: MEASURED AND MODELLED MOISTURE CONTENT IN EAST EXISTING WALL
 Moisture contents are generally similar, apart from severe spikes in modelled moisture content soon after rain events that are not observed in measured values. This discrepancy should be resolved with artificial wetting of the field sensors to test reaction time to wetting events.

The measured and modelled moisture contents (both over a 25mm slice at same location in wall) compare well outside of short-term peaks, where the measured values are less than the modelled values. The MC spikes are important to a freeze-thaw analysis, as this is the time when materials could be saturated enough to cause freeze-thaw damage when coincident with below 0°C temperatures. We speculate that the MC spikes are not as pronounced in the measured values due to slow sensor response, given sensor size and encasement in bentonite clay (which may impact capillary connectivity). After a rain event, the moisture may dry or be redistributed before the sensor can fully react.

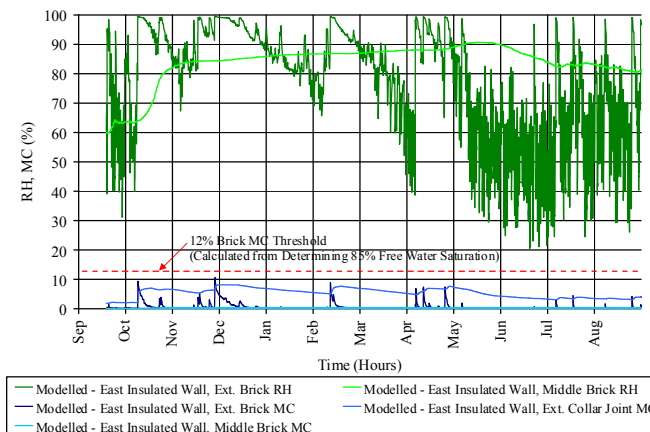
FIGURE 9: MODELLED RH AND MC IN EAST INSULATED WALL
 Brick moisture content in most severe modelled case is 10.6%, which is below the 12% MC freeze-thaw threshold.

In the modelled walls subjected to more severe weather conditions than those experienced in the field (using rain deposition factor of 0.5), there were no instances where freeze-thaw damage was likely to occur (see Figure 9). The maximum moisture content was 10.6% (peaking in the brick soon after rain events). The moisture content in the brick between rain events is typically near 0%. The mortar moisture content is fairly constant between 2-8%. These moisture contents are below the estimated threshold levels of 12% and 13% (brick and mortar respectively) where freeze-thaw damage is expected to occur.

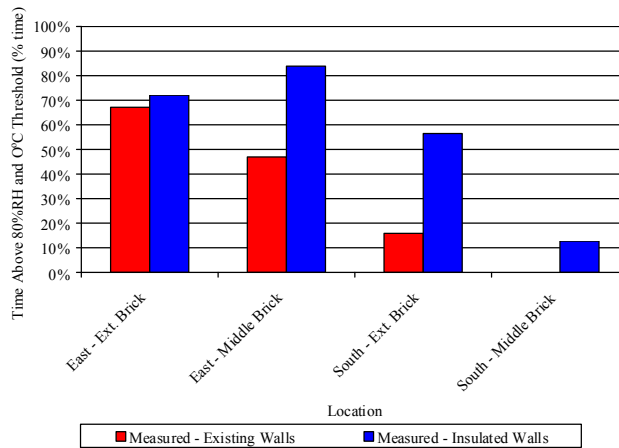
FIGURE 10: MEASURED TIME ABOVE CORROSION THRESHOLDS IN INSULATED AND EXISTING WALLS
 Insulated walls have significantly more time above corrosion thresholds than existing walls, increasing risks for embedded steel corrosion in insulated walls.

There may be a minor increase in embedded metal components corrosion risk for the insulated walls compared to the existing un-insulated walls. Figure 10 shows the time above corrosion thresholds. Corrosion threshold is Time of Wetness (i.e. hrs above 0°C and 80% relative humidity) as defined in ISO (1992).

The modelled walls show no increase in corrosion risk between un-insulated and insulated walls. However, the measured walls show an increased risk. We believe this discrepancy is, in part, due to the nature of the sensor installation, with a wood resistance sensor embedded in the parent material using bentonite clay (see Section 2.2). In addition, moisture transport in the model may occur by liquid transport, while moisture transfer to the sensors is predominantly by vapour diffusion (i.e. slower process). This may result in the sensors showing more time above thresholds after a rain event.

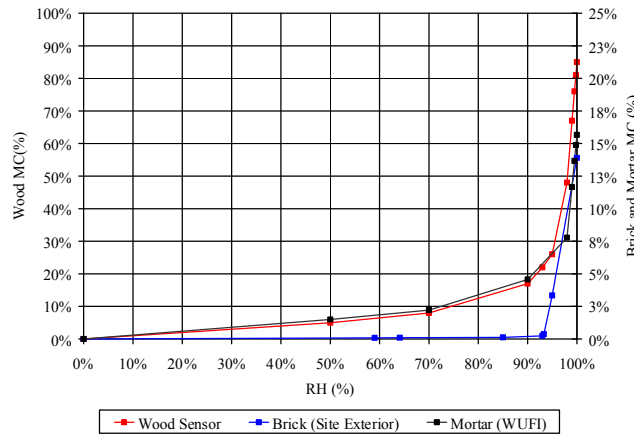
FIGURE 11: MOISTURE CONTENT CALIBRATION – WOOD AND BRICK
 Measurements taken during lab testing of wood sensor installed in brick, as done in the field.

The wood moisture content sensors used to evaluate the brick moisture content, operate accurately in the 20% to 50% wood MC range (corresponding to 0% to 8% MC in this brick), as shown in Figures 11 and 12. The wood moisture content did not exceed 30% (4% in this brick) over the monitoring period due to a lack of wetting, so the upper range of the sensors was not an issue in this case (see Figure 10). However, given that critical limits for freeze-thaw damage correspond to approximately 70% in wood (12% in this brick), these wood sensors would not adequately evaluate moisture content near the threshold in this brick.

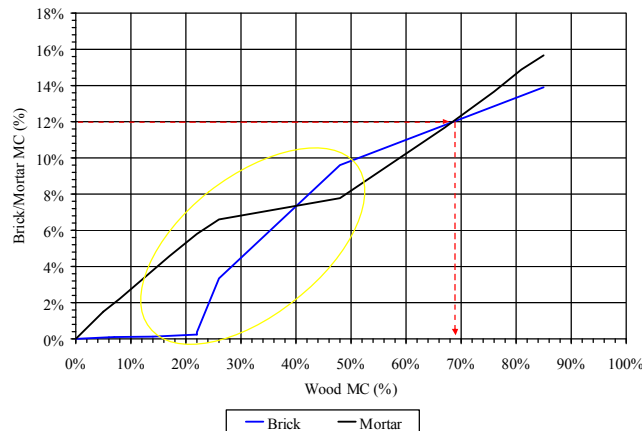
FIGURE 12: MOISTURE CONTENT CORRELATION – BRICK VS WOOD
 Corresponding Brick MC for given Wood MC reading. Wood sensors operate accurately in the range circled in yellow. Critical moisture content range for brick freeze-thaw analysis (and corresponding wood moisture content), shown with dotted red arrows.
